City of Melbourne

Permeability Testing of Permeable Pavement Systems

Version 01 / July 2017

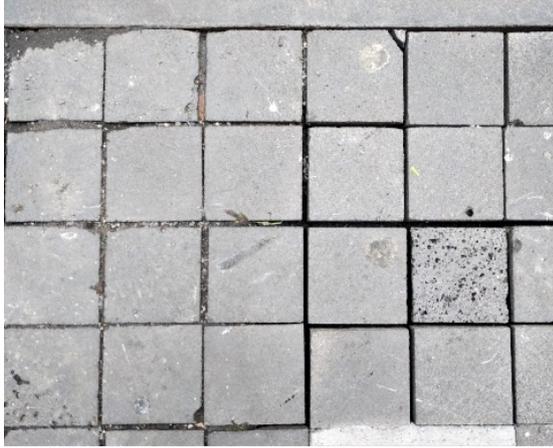
The results for infiltration testing prior to cleaning showed that all 14 sites at the four locations were compromised by surface clogging (Figure 1, Figure 2, Figure 3 and Figure 4). The results suggest the assets in Abbotsford St and Harris St have failed and demonstrate minimal if any functional effectiveness and infiltration capacity. The systems at Eades Place and Collins St demonstrate some functionality but there is potential for this to be greatly improved.

Figure 1
Modular paving, Collins St, Melbourne

functional performance. ***On this basis, it is recommended that full cleaning of the entire permeable pavement asset at all four locations is undertaken.*** The Abbotsford St and Harris St systems should be a priority due to their very low level of functionality.

Council should ***immediately replace the infill media*** (quarter minus (2-5 mm) crushed rock) between the modular bluestone that was removed during cleaning at the location in front of 333 Collins St ***as this currently presents a potential trip hazard*** that needs to be rectified as a priority. Replacement of this material should be planned to occur immediately following future cleaning.

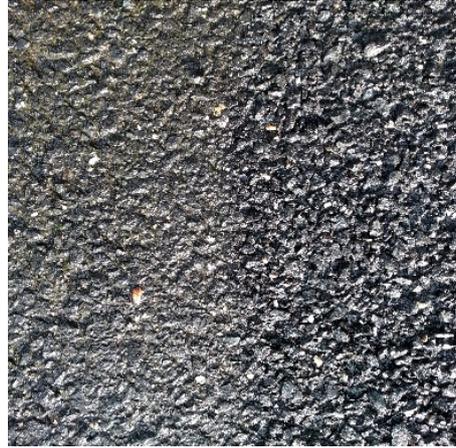
Figure 2
Permeable asphalt, Eades Pl, West Melbourne

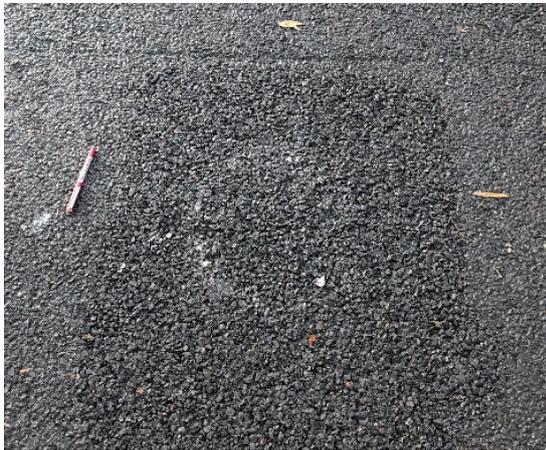
Figure 3
Permeable asphalt, Abbotsford St, North Melbourne

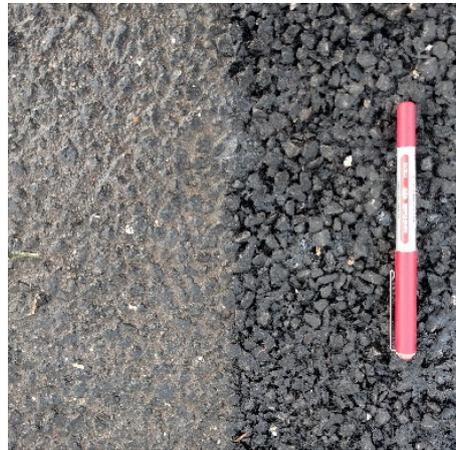
Figure 4
Permeable asphalt, Harris St, North Melbourne
