City of Melbourne

# Permeable pavements maintenance and monitoring outcomes

Version 03 / December 2019

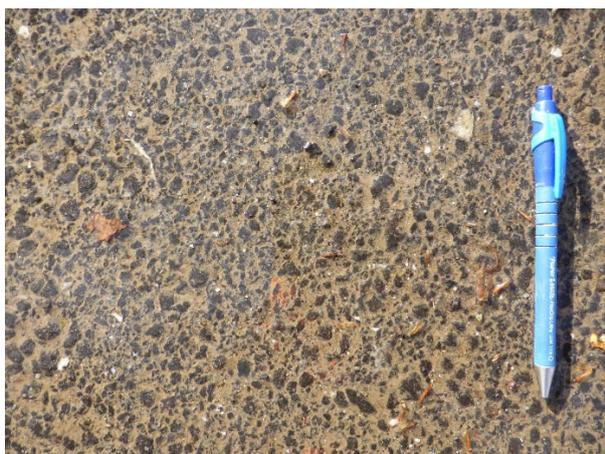
Figure 1. Before pressure washing (wet), Harris St

The results demonstrated that pressure washing via the through approach is the most effective cleaning method in improving performance. This method was able to restore infiltration rates beyond 12 months, with over 55% of the testing sites at Harris St providing greater than 300mm/hr.

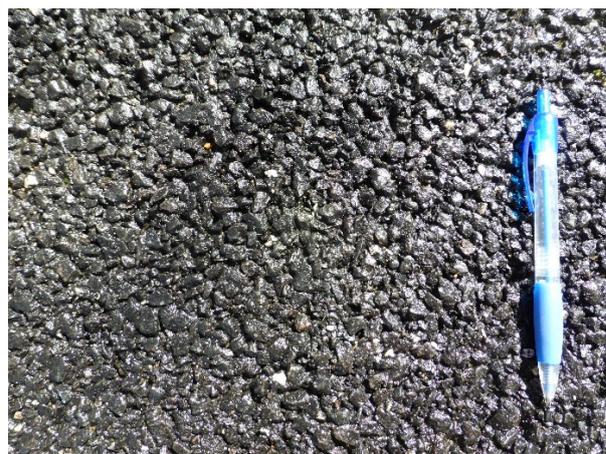
Figure 2. After pressure washing (wet), Harris St
