3.2 Infiltration rates over time

3.2.1 Summary of outcomes

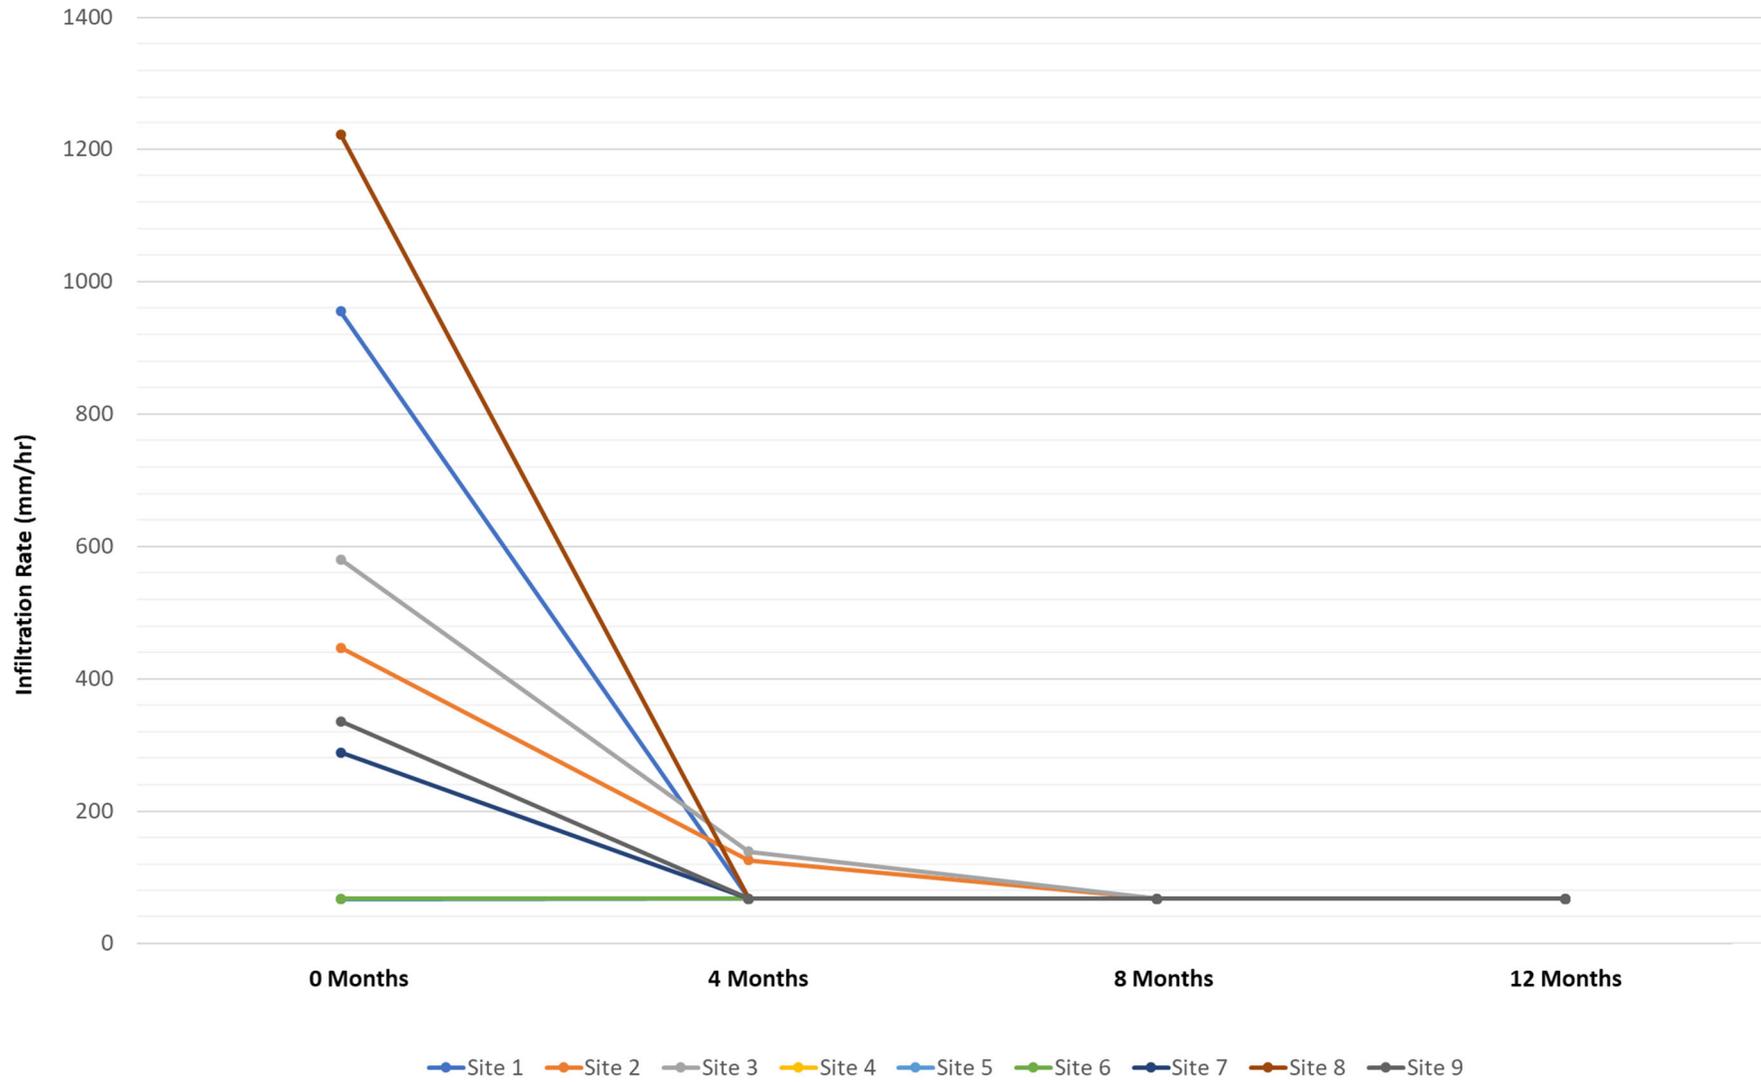
Figure 16. Eades Place infiltration testing results

Table 7 below includes the median infiltration rate recorded for each location across one year at 4 month intervals. The Eades Place and Harris St data is graphed in Figure 16 and Figure 17 respectively. Median rates were selected to limit the influence of outliers. Infiltration tests exceeding 45 mins with more than 25% of the test remaining were ceased and given a default infiltration rate of 68 mm/hr. Sites that recorded infiltration rates below 100 mm/hr were deemed effectively clogged (coloured in red).

Change in infiltration rates over time - Eades Place

- The dry vacuuming cleaning method was ineffective in restoring permeable pavement infiltration rates as demonstrated by the initial testing after cleaning. A test was conducted at Site 5 at the 4 month period to confirm this outcome. Further testing across Sites 4, 5 and 6 were therefore not conducted.

- The dry vacuuming and pressure washing (sweeping approach) was effective in restoring permeable pavement infiltration rates for less than 4 months. Tests at Sites 7, 8 and 9 at the 4 month period concluded the area to be effectively clogged. Further testing across Sites 4, 5 and 6 beyond the 4 month period were therefore not conducted. It is assumed the restored functionality of the pavement was likely solely due to pressure washing.

- Pressure washing, via two rounds of the sweeping approach, was able to restore infiltration rates for less than 8 months. Tests at Sites 1, 2 and 3 at the 8 month period concluded the area to be effectively clogged. Further testing beyond the 8 month period confirmed this.

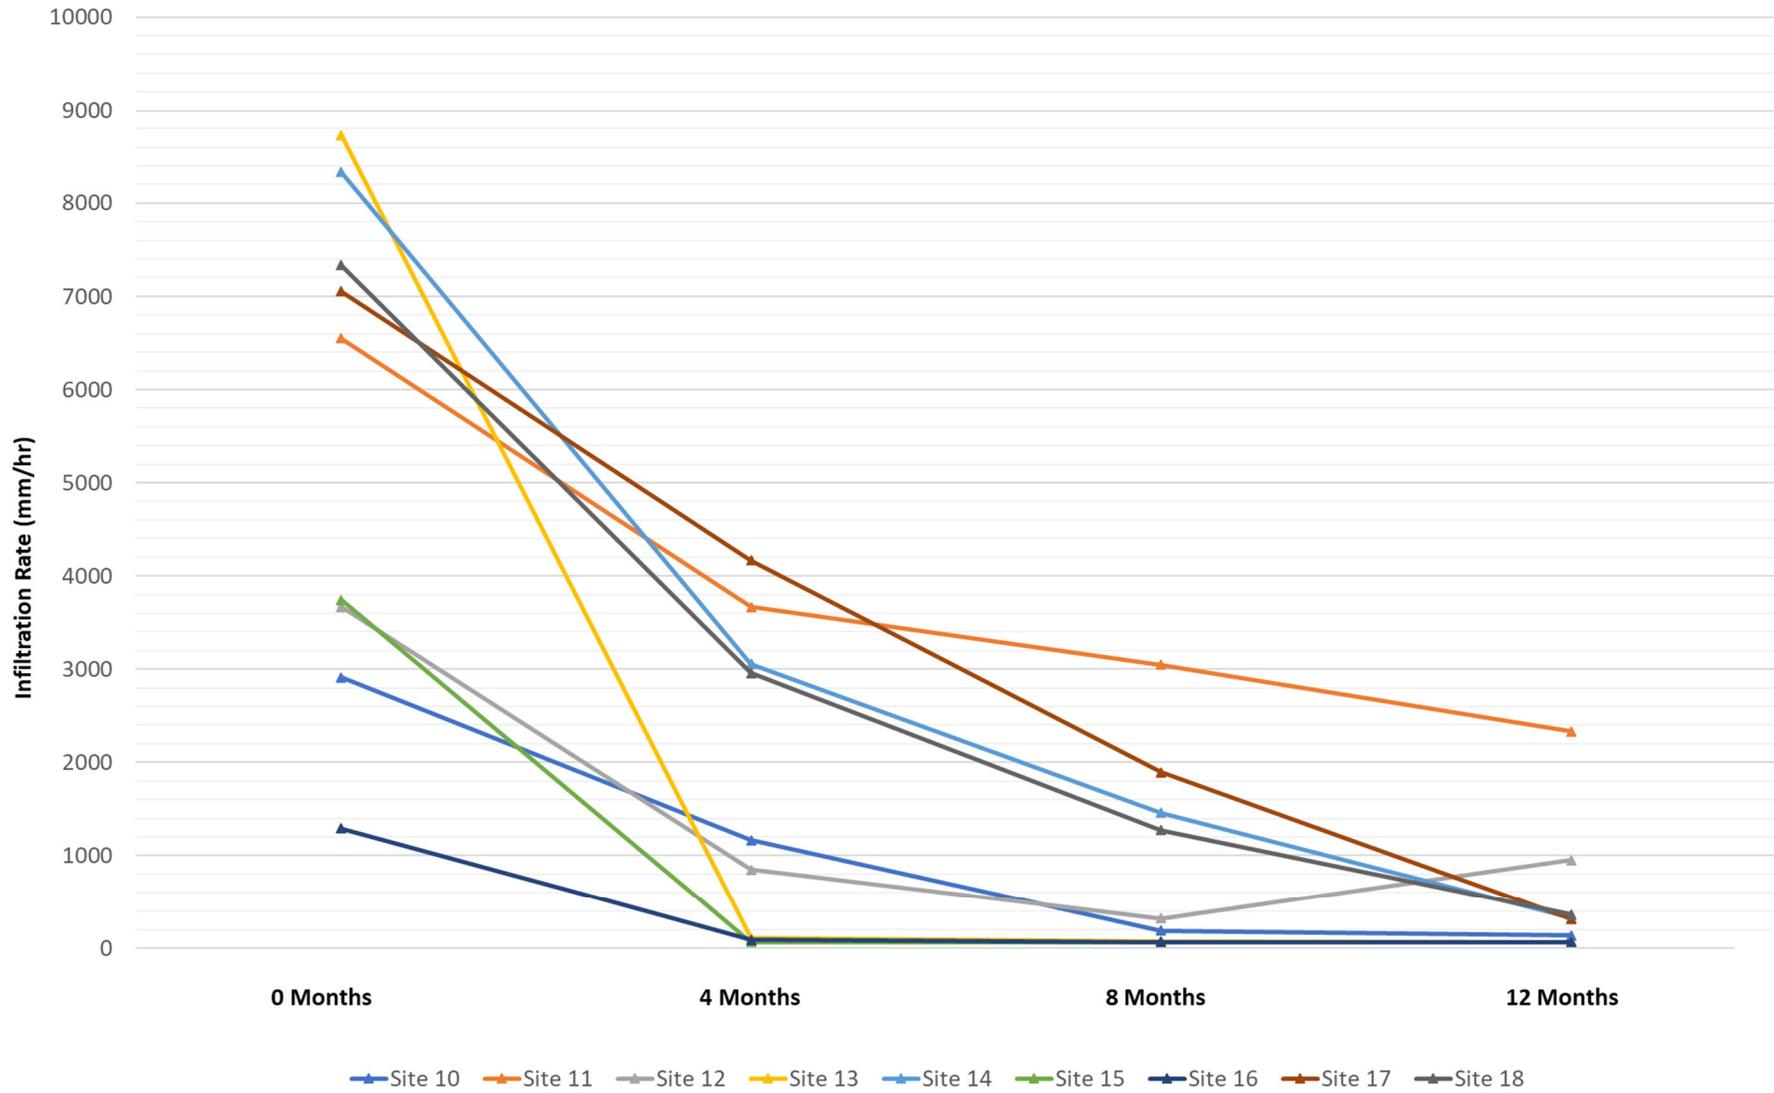
Figure 17. Harris St infiltration testing results

Change in infiltration rates over time - Harris St

- Pressure washing, via the thorough approach, was able to restore infiltration rates beyond 12 months, with over 55% of the Sites are Harris St providing greater than 300mm/hr.

- The evidence suggests that there are different types of clogging occurring, one is incremental reductions of infiltration capacity due to sedimentation. The second is the development of patches that are quite clogged with adjacent areas retaining high infiltration rates. This is likely due to organic and inorganic matter deposition in some places and not in others as well as preferential flow paths and low points concentrating inflows and, hence clogging. The first mode was primarily observed at Eades Place which is likely due to its largely uniform surface. Both modes of clogging appear to be present at Harris St, with several sites becoming clearly clogged (Sites 13, 15, 16) amongst other well performing Sites. Interestingly, sites that reside within the centre of each of the cleaned areas (Sites 11, 14, 17, Figure 27), retained high infiltration rates. This could be due to several factors:

- **Pollen:** The fast rate of degradation at Sites 13, 15 and 16 in Harris St is likely due to an accumulation of tree pollen and granitic sand. The pollen falls from the above London Plane trees and settles into the permeable asphalt matrix with rain. This breaks down and can result in biological clogging. Eades Place is planted with Eucalyptus trees which do not drop significant volumes of pollen.
- **Sediment:** The permeable asphalt at Eades Place collects runoff from 50% of the adjacent road. This runoff transports sediments to the permeable asphalt and contributes to clogging. Sites adjacent to the road (Sites 1, 4 and 7). The permeable asphalt areas at Harris St do not collect runoff from other surfaces so the permeable surface is 100% of the catchment.

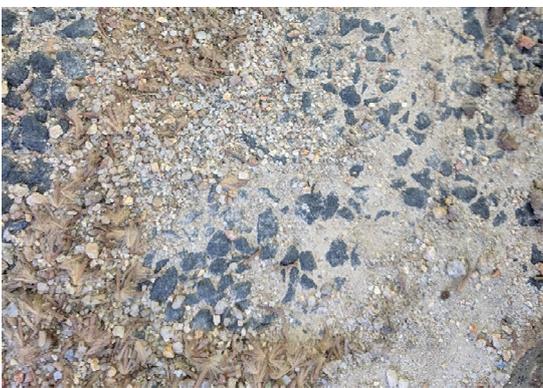
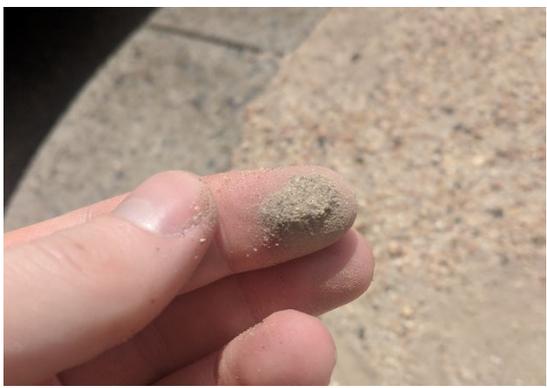
Pollutant		
Tree pit toppings (granitic sand)

- **Tree pit toppings:** Both sites are exposed to fine granitic sand as a pollution source from the street tree podiums. This pollutant is transported by wind and settles into the permeable asphalt matrix with rain.
